Morphological and elemental analysis of space launch vehicle debris retrieved from a Philippine coastal area

Abstract

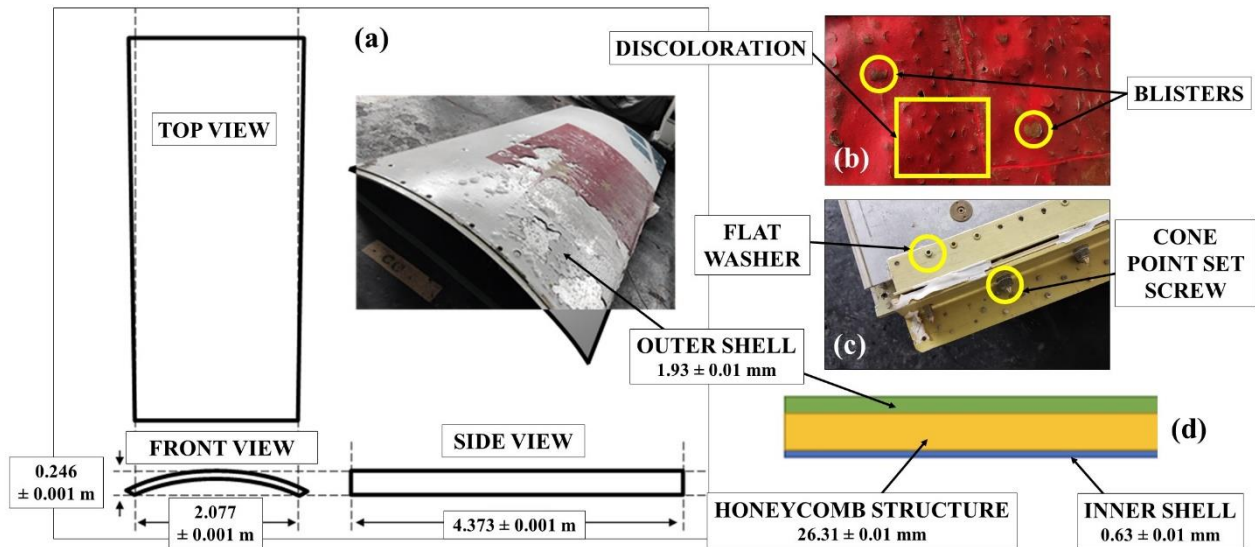
A reconstruction of the payload fairing debris with measurements is seen in Fig. 1a. The payload fairing debris/panel measures about 4.373 ± 0.001 m in its long dimension while the chord length is about 2.077 ± 0.001 m on one side. The height or the rise of the debris is about 0.246 ± 0.001 m. Close up inspection of the outer shell/cladding revealed signs of oxidation, discoloration, and structural deformation possibly due to burning -

either during ascent, descent, or ejection on drop zone (Fig. 1b). The inner shell/cladding is a metal finish with various cone point set screws and flat washers. It must be noted that the debris/panel is not made of purely solid metal but rather layers of different materials in varied configurations. The outer cladding/shell is a 1.93 ± 0.05 mm thin sheet of painted metal with cardboard padding beneath it (Fig. 1d). The padding is glued to a 26.31 ± 0.05 mm high metal honeycomb structure opened in both ends. It is then further glued to the 0.63 ± 0.05 mm thick inner metal cladding/shell. The probable reasoning for this design could be to promote a durable but lightweight payload fairing suitable for launch vehicles.

Figure 1. (a) Reconstruction of the payload fairing debris. (b) Discoloration and blisters on the outer shell possibly due to burning. (c) Screws (d) The cross-section measurements of honeycomb sandwich panel.

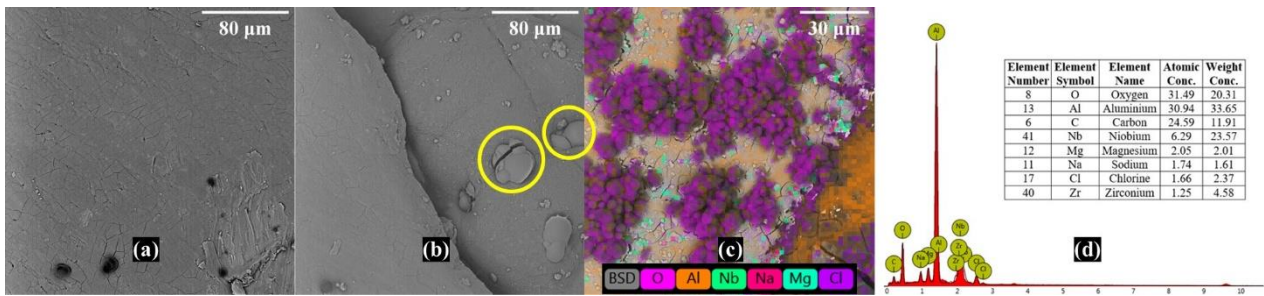
Emission spectra of the honeycomb panels (Figures 2 - 3) reveal that they are aluminum-based. The high concentration of oxygen possibly suggests the presence of aluminum oxide, which is used in aerospace and space launch vehicles due to its mechanical strength, low thermal conductivity, and high corrosion and electrical resistance [6-7]. Alumina ceramic fibers are also used for providing structural and thermal insulation, as well as for reinforcing materials by being dispersed within composite systems consisting of metals, ceramics, or polymers [8-9]. Surface analysis revealed cracks and globular-like protrusion on the material. While the actual cause of these structures merit additional research, it is noteworthy that launch and jettison generate stresses that may result to cracks and protrusions.

Figure 2. Inverted honeycomb portion of the debris at (a-b) 1000x magnification. A representative image was used to generate the (c) combined elemental map and the (d) elemental spectrum of the sample.

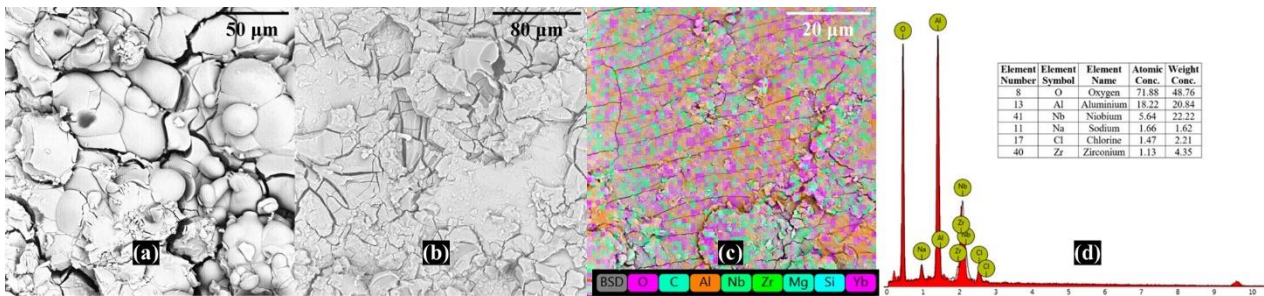
Figure 3. Honeycomb panel of the debris at (a) 1350x and (b) 1000x magnifications. A representative image was used to generate the (c) combined elemental map and the (d) elemental spectrum of the sample.

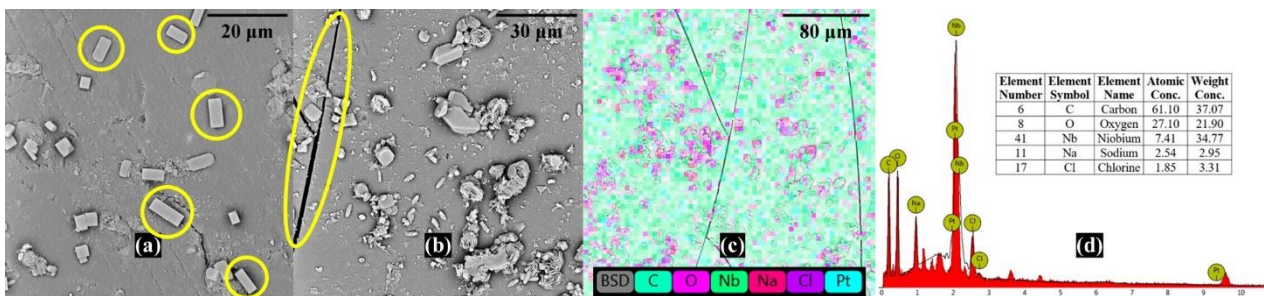
Paint was also recovered on the debris surface. The paint surface morphology shows a mostly smooth surface with aggregates almost equally distributed. Rectangular microstructures as well as big cracks are seen in the high magnification images as shown in Figure 4. The elemental composition of the paint sample comprises mostly of carbon and oxygen with considerable amount of niobium which is commonly used in anti-corrosion paints. SEM images and emission spectrum of the cardboard padding are shown in Figure 5. shows hollow, hexagonal-like microstructures making the padding porous. This hints on the function of the padding to dampen the sound waves produced during launch. Emission spectrum shows that the padding is mostly carbon and oxygen with some hints of magnesium and bromine, which hints on the use of magnesium bromide commonly used as flame retardant.

Figure 4. Paint chip at (a) 3700x and (b) 2500x magnifications. A representative image was used to generate the (c) combined elemental map and the (d) elemental spectrum of the sample.

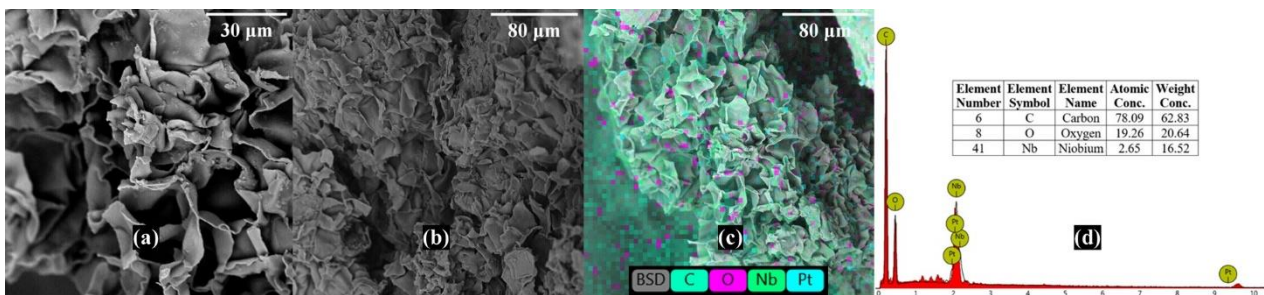
Figure 5. Acoustic panel at (a) 350x and (b) 1000x magnifications. A representative image was used to generate the (c) combined elemental map and the (d) elemental spectrum of the sample.

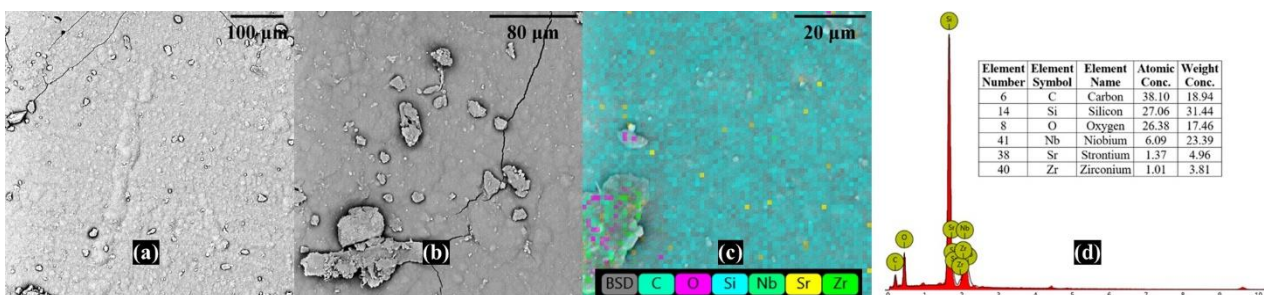
Figures 6 shows that the sealant used in the debris is silicone-based, which is known for its adhesive properties. Lastly, the images of the washer screw (Figure 7) show rough morphology across the different magnifications. The presence of carbon and zinc hints that stainless steel is used on washer screw.

Figure 6. Adhesive at (a) 500x and (b) 1000x magnifications. A representative image was used to generate the (c) combined elemental map and the (d) elemental spectrum of the sample.

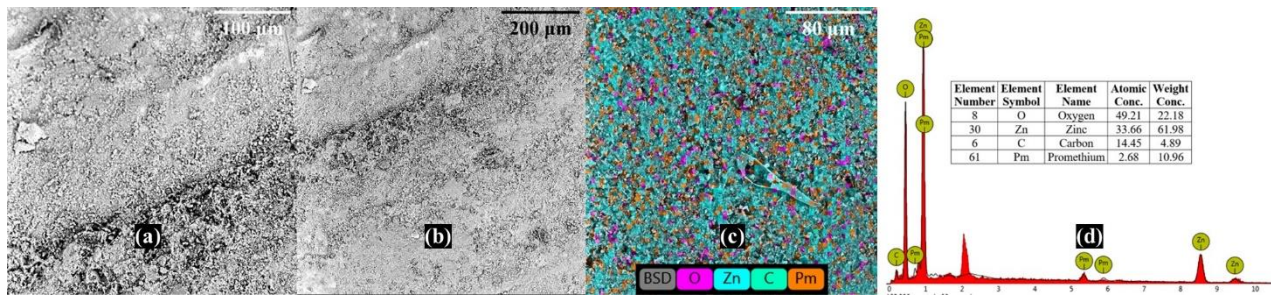
Figure 7. Washer screw at (a) 710x and (b) 360x magnifications. A representative image was used to generate the (c) combined elemental map and the (d) elemental spectrum of the sample.
