## Shoreline Change Analysis in New Washington, Aklan using Digital Shoreline Analysis System (DSAS)

### Abstract

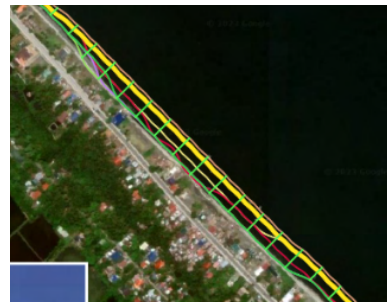
Figure 4. Perpendicular transects along the shorelines per epoch.

In this study, we utilized Shoreline Change Envelope (SCE), Net Shoreline Movement (NSM), End Point Rate (EPR), and Linear Regression Rate (LRR) values. Positive values of EPR and LRR indicate accretion, while negative values indicate erosion. The SCE and NSM provide a general idea of how much the shorelines deviate from each other (Estrada et al., 2020). For a better understanding and detailed analysis, the shoreline was divided into segments based on observable inflection points—locations where the results indicated a change from erosion to accretion or vice versa.

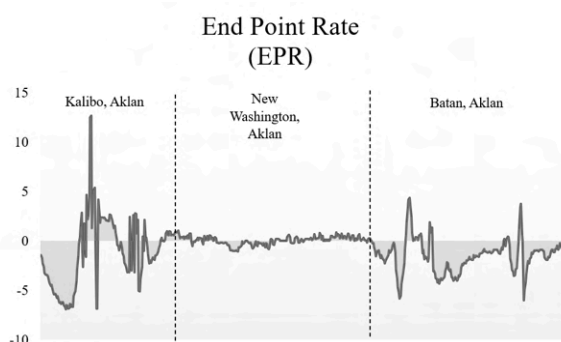
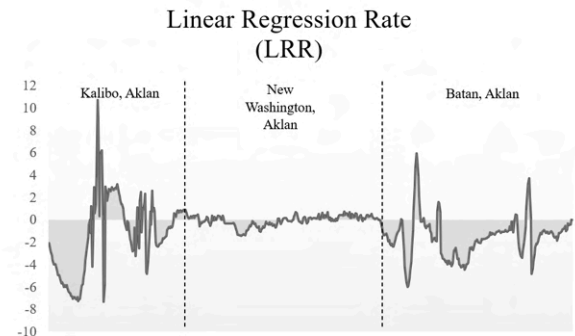
Figure 6. End Point Rate (EPR) and Linear Regression Rate (LRR) results

As mentioned, the End Point Rate (EPR) and Linear Regression Rate (LRR) provide information on the nature of sedimentation, indicating erosion for negative values and accretion for positive values. Figure 6 illustrates the EPR and LRR values per transect. The municipality of Kalibo showed the highest fluctuation across the included shoreline, which can be attributed to its direct proximity to the estuaries of the Aklan River and the presence of the Bakhawan (Mangrove) Park, with its highest approximate rate of 12.67 m/yr. Additionally, sediments are continuously deposited towards the sea, specifically northeast of Bakhawan Park, feeding the sand spits (see Figure 11), which causes fluctuations in values within each transect, with a rate of 6 m/yr.

The third part of the graph in Figure 6 includes the southernmost edge of the New Washington shore and the northernmost part of Batan, Aklan. Most of these areas experience erosion, with an end-point rate of 4.3 m/yr and a linear regression rate of 5.91 m/yr. Located between these areas is Batan Bay, where a port is also present; thus, the continuous erosion along the shoreline can be attributed to the flow of water into the bay.

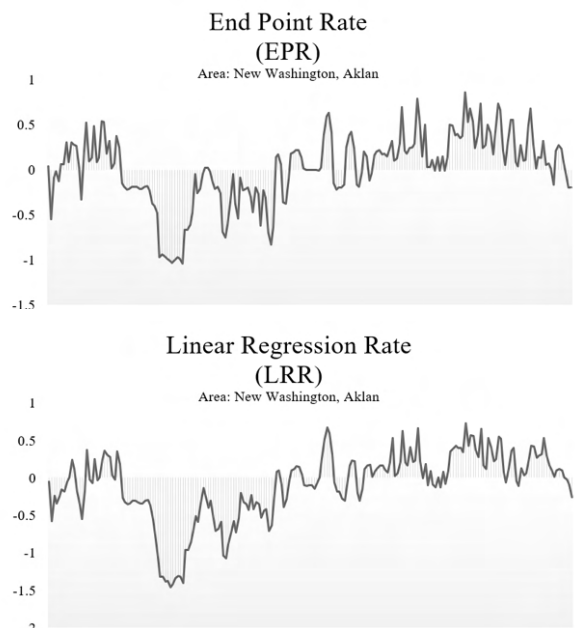
Figure 7. End Point Rate (EPR) and Linear Regression Rate (LRR) results for New Washington, Aklan

Moreover, most of the shoreline along New Washington shows a linear trend, except for the area near ASU-New Washington and a local resort, Sampaguita Garden Resort, where a faster rate of erosion (approximately 1.46 m/yr) is visualized as a sudden dip in the chart in Figure 7. This poses a danger to the area and must be continuously monitored.

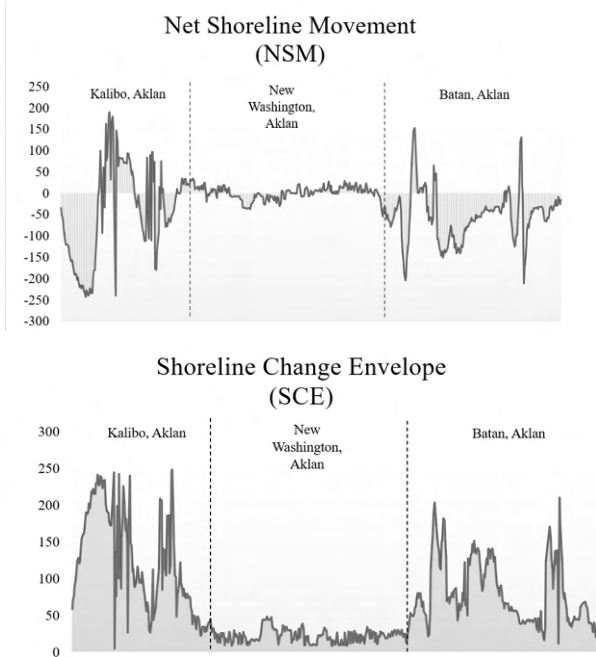
Figure 8. Net Shoreline Movement (NSM) and Shoreline Change Envelope (SCE) results

NSM and SCE provide information on how much the shoreline has changed from the baseline. A general observation was determined in the northernmost part of the shoreline data, due to the fast and massive growth of Bakhawan Park, a mangrove sanctuary, in Kalibo, as measured by the transects created, which caused noisy parameter values. These noise or fluctuations may be attributed to the disturbed sediment movement caused by the mangrove sanctuary and discharge from Aklan River. Nevertheless, both NSM and SCE indicate that from the baseline, i.e., Epoch 1, the shoreline movement extends up to

190 meters in Kalibo, Aklan, primarily due to the aforementioned significant growth of the mangrove sanctuary. However, erosion is also evident in the area, with approximately 250 meters of eroded land area near the estuaries of the Aklan River. Additionally, the area of Batan, Aklan, has also experienced accretion over the years, with 153 meters gained since 1985. This can be justified by the establishment of recreational and residential areas near the shore.

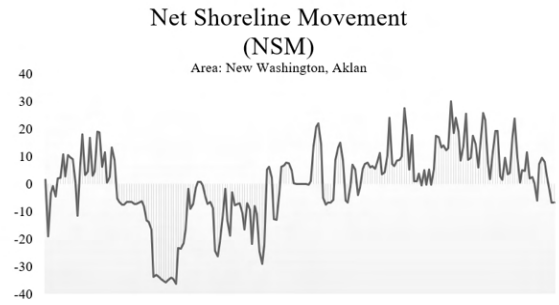
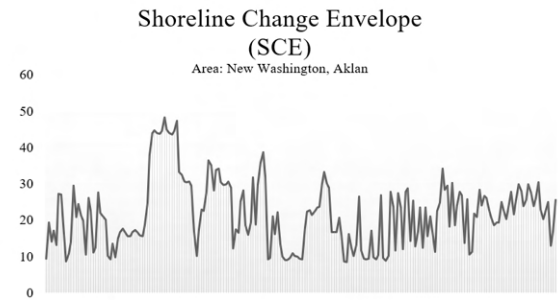
Figure 9. Net Shoreline Movement (NSM) and Shoreline Change Envelope (SCE) results for New Washington, Aklan

However, zooming into New Washington, we can observe in both the graphs of NSM and SCE that the same area with the highest rate of erosion has eroded up to 40m in 32 years, specifically in Barangay Tambac, Barangay Poblacion, and near Aklan State University. The continuous erosion in this area may pose risks to establishments and residents nearby. Additionally, there is an accumulation of coastal sediments extending from the shoreline in areas near Barangay Ochando.
